NIST NCSTAR 1-5A

**Federal Building and Fire Safety Investigation of
the World Trade Center Disaster**

Visual Evidence, Damage Estimates, And Timeline Analysis

William M. Pitts
Kathryn M. Butler
Valentine Junker

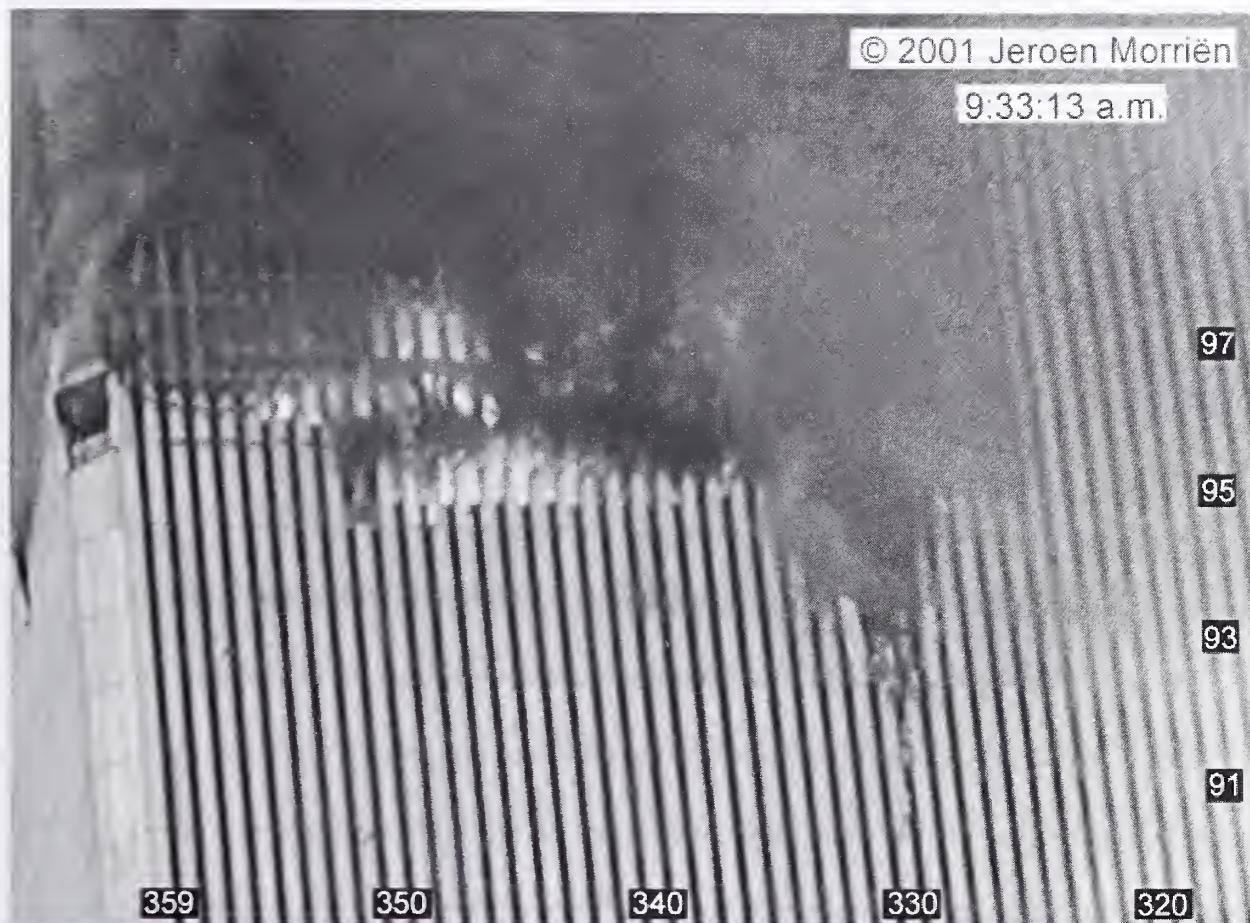
Figure 8–46 shows a view of the south face taken at 9:33:13 a.m. By this time, the intense fires on the 96th and 97th floors near the western edge of the face have diminished greatly, and flames are no longer prominent in the windows nearest the edge, while flames closer to the center have receded back into the windows. It is now possible to observe individual windows on the 96th, 97th, and 98th floors all the way from the western edge to windows 96-344, 97-344, and 98-344. Note that it appears as if these windows on the 98th floor are missing. It is not possible to conclude this definitely, since it is possible that smoke has been deposited on the windows, which would make them dark and thus appear to be missing. In either case, there are no obvious flames present in this area of the 98th floor.

Figure 8-46. This cropped image shows a portion of the south face of WTC 1 at 9:33:13 a.m. The photograph has been enhanced, and column and floor numbers have been added.

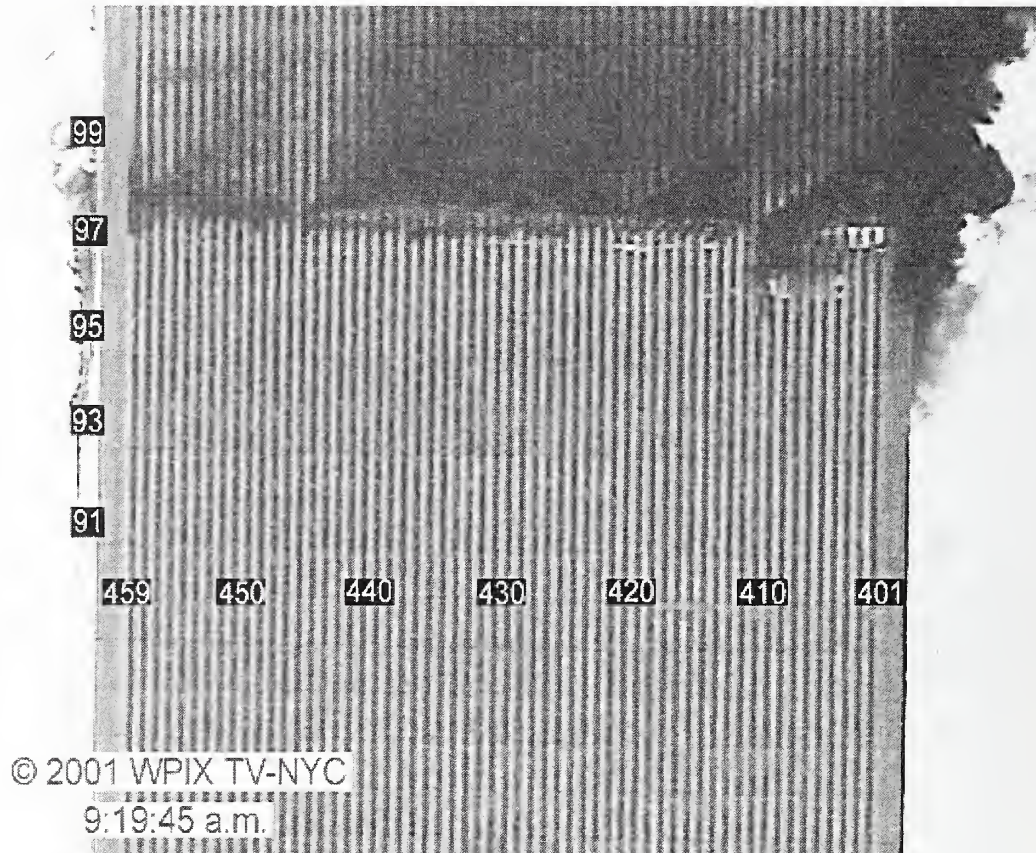
One such image taken from a video recorded at 9:19:45 a.m. is shown in Figure 8-47. The fire distribution is consistent with that observed from the ground at 9:14:46 a.m. in Figure 8-31. A flaming region is prominent at the south edge of the 97th floor over windows 97-401 to 97-405. While these flames appear to fill the windows, they do not seem to extend out of them. Further toward the north on the 97th floor, a number of relatively small fires are visible through the lowest portions of the window openings. Most of these flames are observed between the intensely burning corner and the center of the face. When viewing the video, it appears as if this gentle burning is relatively continuous across this length. The only location on the face where flames are apparent even further to the north is in window 97-455. Keeping in mind that the bases of the windows are raised 15 in. from the floor, it is clear that most of the intense fires that were burning earlier on the west side of the 97th floor have died down to a condition in which widely distributed flames are gently burning near the floor on the remaining fuel. A comparison of Figure 8-47 with Figure 8-30, which was recorded at 9:10:58 a.m., provides a good visual measure of how much the fire intensity on this floor has decreased over this nearly 9 min period.

The only other floor on which flames are apparent in Figure 8-47 is the 96th. A region of fire, which fills the window openings, runs from window 96-404 to perhaps window 96-410. The flames in windows 96-408 and 96-409 extend from these windows. As discussed above, fire was present in the

same general location around 9:11 a.m. (see Figure 8–30). Two regions of small flames around windows 96-412 and 96-414 are visible just to the north of the flaming area. Even though these flames are similar in appearance to the dying flames just above on the 97th floor, there is a major difference. Based on the visual evidence, there has not yet been an intense burning phase in this region of the 96th floor. The absence of smoke marks on the nearby aluminum cladding is consistent with this conclusion.

Figure 8-47. This image of the west face of WTC 1 is a frame captured from a video recorded by a news helicopter at 9:19:45 a.m. The image has been enhanced by adjusting the intensity range, and areas to the left and right of the tower are saturated. Column and floor numbers have been added.

It is interesting to compare Figure 8–47 with the view of the south face shown in Figure 8–44. These images were taken approximately 30 s apart. While there are intense flames issuing from numerous windows on the 95th, 96th, and 97th floors on the west side of the south face, from the west flames are only observed near the south corners of the 96th and 97th floors, and they do not appear to be nearly as intense. These observations indicate that either the flames on the south face are isolated near the outer wall or that interior portions of these floors are actually hidden from view by obscuring smoke or walls. There is no indication of fire on the 95th floor from the west. Figure B-4 in Appendix B shows that there were a group of rooms in the southwest corner of this floor with a wall extending to column 95-350. The walls associated with these rooms may still be in place, protecting the west side of the floor from the fire raging on the south face. One piece of visual evidence argues against this conclusion. In Figure 8–44, smoke is observed coming from windows 95-349 and 95-350 on the south face, and there is evidence of façade damage below both of these windows. This suggests that both windows were removed during the

aircraft impact and subsequent fireball. It is unclear if such damage could have taken place without severely damaging the wall located between these two windows.

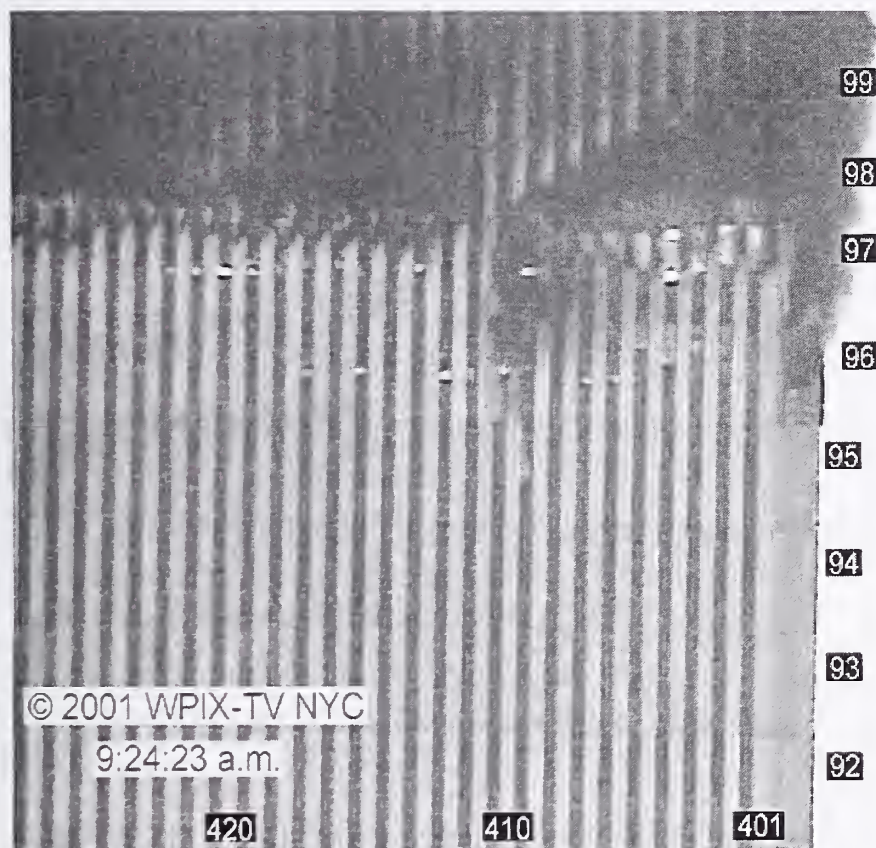
Figure 8-48 shows a closer view of the south side of the west face captured from a news helicopter video recording at 9:24:23 a.m. The general appearance is very similar to that of Figure 8-47. The relatively intense fires burning at the south edges of the 96th and 97th floors are still present. A number of small, apparently isolated, fires can be seen on both of these floors. On the 96th floor there are now indications of fires as far north as window 96-417. This is slightly farther than observed at 9:19:45 a.m. and suggests that these low-level fires are slowly moving toward the north along the outer west wall of the 96th floor. The image has sufficient resolution to just identify, albeit with some uncertainty, whether window glass is still in place. It appears that the glass is missing from those windows where the small fires are visible and is intact in windows at the intervening locations.

Figure 8-48. This image of a portion of the west face of WTC 1 is a frame captured from a video recorded by a news helicopter at 9:24:23 a.m. The image has been enhanced by adjusting the intensity range, and the area to the right of the tower is saturated. Column and floor numbers have been added.

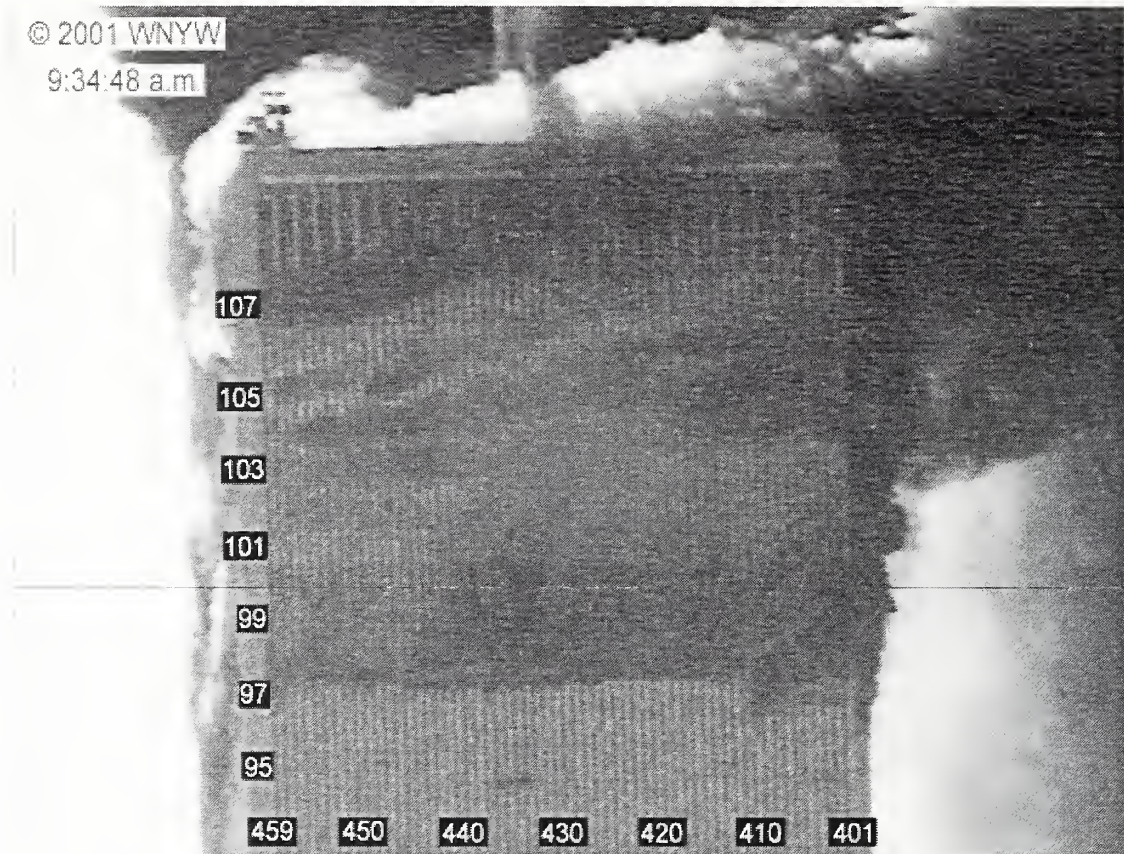
Figure 8-49 shows another view of the west face of WTC 1 taken from a video that was recorded from a helicopter at 9:34:48 a.m. The fires on the south ends of the 96th and 97th floors are no longer as prominent as they were earlier. In fact, at this distance and clarity it is difficult to identify fires in these locations. There is evidence of low-intensity fires further to the north on both the 96th and 97th floors. The most visible flames on the 96th floor are in windows 96-224 to 96-226. This area is north of where flames were observed earlier, indicating that the fires are continuing to spread slowly toward the north.

Figure 8-49. This image of the west face of WTC 1 is a frame captured from a video recorded by a news helicopter at 9:34:48 a.m. The image has been enhanced by adjusting the intensity range, and some areas to the left and right of the tower are saturated. Column and floor numbers have been added.

Even at the distance from which Figure 8-49 was taken, a black mark is visible running across the tops of windows 94-433 to 94-436 on the 94th floor. These marks are not evident in Figure 8-47, which was taken at 9:19:45 a.m. This suggests that smoke began to flow from these windows at some point between these two times. A review of video recordings shows that visible smoke was apparent coming from these windows starting around 9:26 a.m. As discussed earlier, windows had been opened in this general area as early as 9:04 a.m. Recall also that several windows are open just to the north on the 95th floor. There is still no indication of smoke coming from these windows.

Even though the fires on this face appear to have nearly died down by the end of the period, there are still large quantities of smoke flowing from windows that have been broken out higher on the tower. In particular, heavy plumes of smoke are coming from the north side of the 107th floor and from the south side of the 104th floor. The plumes from the higher windows seem to be heavier than those coming from the floors where fires had been observed on this face, i.e., the 96th and 97th floors.

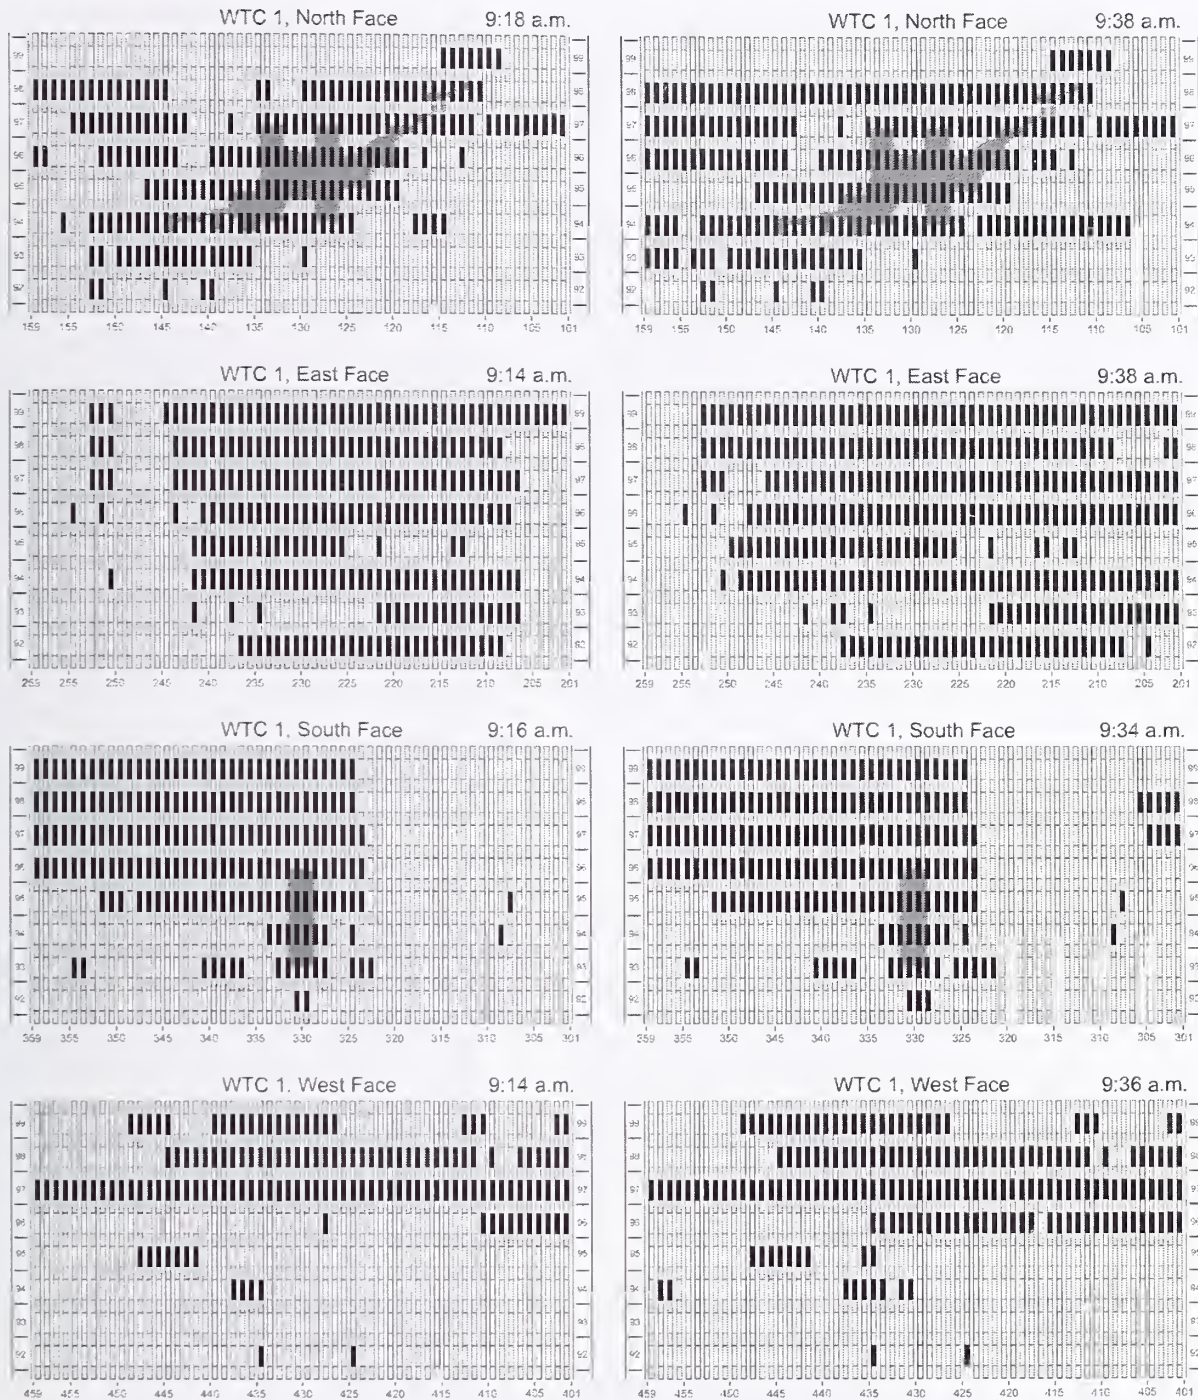
Figure 8-50 compares maps for open windows on the four faces of WTC 1 for times near the start and end of the current time period. These maps capture the general trends that emerge from the detailed discussion of fire behavior during the period. In particular, on the north face fires on the 93rd, 94th, 96th, and 97th floors breached walls and entered northeast corner rooms, and the contents inside began burning. A new region of fire grew along the north face on the 94th floor to the west side of the aircraft impact

Figure 8-50. Maps for the 92nd through the 99th floors compare missing window glass for the four faces of WTC 1 at two times, around 9:18 a.m. and roughly 17 minutes later. The color coding used for the maps is indicated in Figure 5-1.

cavity. The changes in window conditions on the east face reveal that the fires that entered rooms at the northeast corners of the 93rd, 94th, 96th, and 97th floors also removed windows on the east faces of the rooms. It is also clear that fires that were originally present near the center of the face on the 94th, 95th, 96th, and 97th floors had begun to slowly spread toward the south. On the south face there was very little fire spread during the period. The same is true for the west face, but there are indications that fires on the 96th floor had begun to spread from the southwest corner back toward the north face.

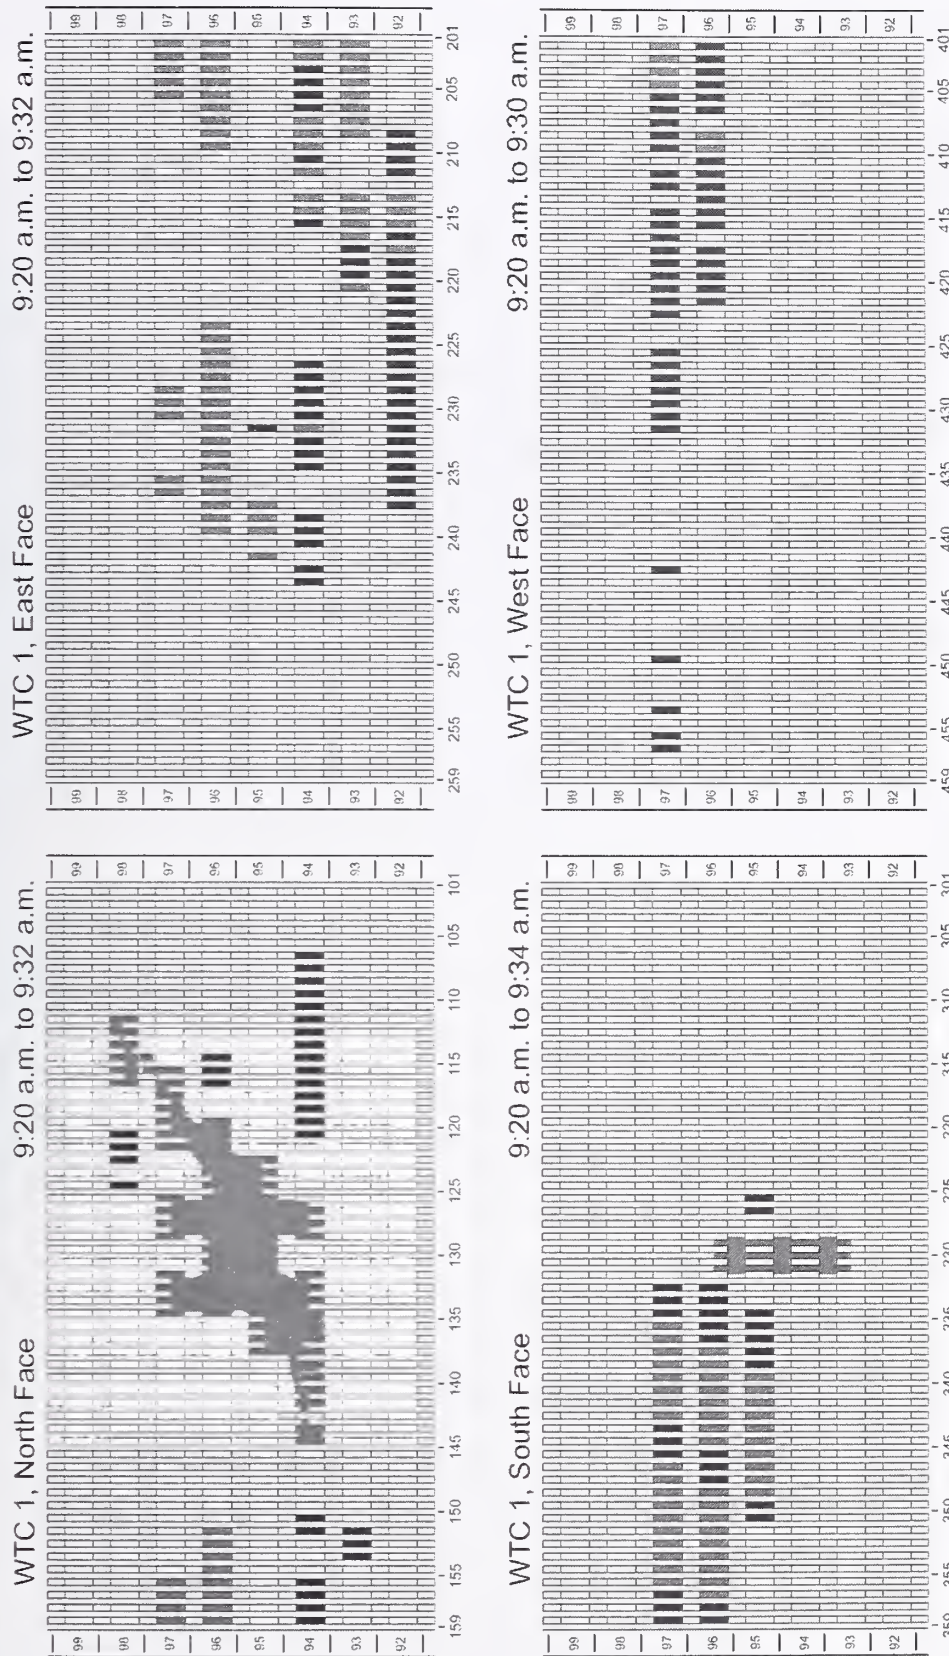
The effects of the life cycle of the fires are also apparent in comparisons of the integrated fire maps prepared for the different time periods. Figure 8–51 shows integrated fire maps on the four faces for the current period from 9:18 a.m. to 9:35 a.m. These maps can be compared with the maps for the two earlier periods shown in Figure 8–33 and Figure 8–14. Such a comparison indicates that there are many windows where fire was observed during the earlier periods where it is no longer visible. These include windows near the aircraft impact area on several floors of the north face, windows on multiple floors around the center of the east face, and many windows on the 97th floor on the west face.

On the north and east faces the windows with observed fire appear to surround areas near the centers of the faces where the fires had already died or were dying down. This suggests that fire spread along the north and east peripheries of these floors has occurred primarily by horizontal fire movement in both directions away from regions initially ignited near the centers of the faces. The fire distribution on the south face indicates that fire spread and growth had occurred differently than on the north and east, with large fires growing and spreading nearly simultaneously on multiple floors at the western side of the face. The integrated fire distribution on the west face reflects both the very rapid fire spread that was observed earlier across the 97th floor and the much slower fire spread from west to east that was observed on the 96th floor.

Figure 8-51. Maps of integrated fire observations between 9:19 a.m. and 9:35 a.m. are shown for the four faces of WTC 1. Colors represent the highest intensity fire observed in a window using the color scale defined in Figure 5-1.

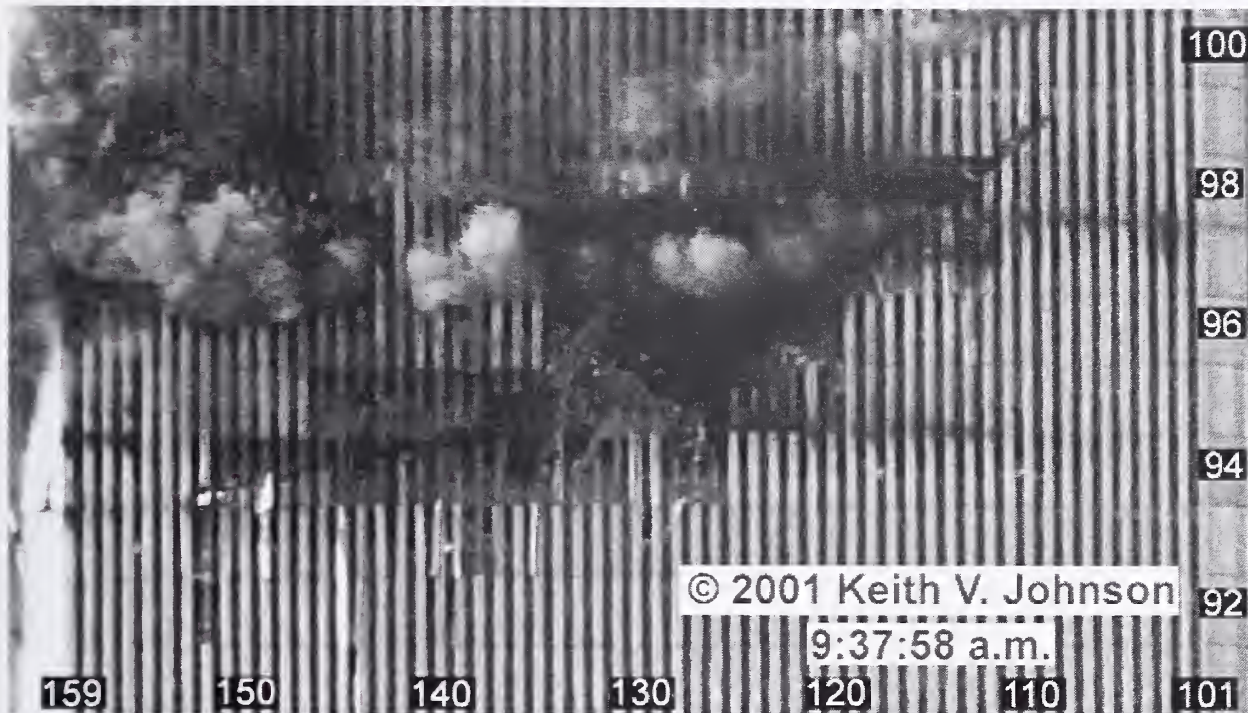
A portion of a photograph showing the fire floors on the north face of WTC 1 at 9:37:58 a.m. is reproduced as Figure 8–52. This photograph was taken just over two minutes later than the image shown in Figure 8–38. The fire on the 98th floor has spread over a wider area and has grown in intensity during this time. Fires are observed (not continuously) from window 98-122 to window 98-150. Even though the flames extend over roughly half the length of the floor, and in some locations appear to fill the volume behind the windows, there is very little smoke and flame evident coming from the 98th floor windows. This is likely another case where the fire gases are exhausting elsewhere than through nearby windows.

Only a few small isolated fires are visible elsewhere on the north face. A low-level fire is still burning on the 94th floor to the west of the aircraft impact cavity. This is the remnant of the fire that first appeared in this area around 9:18 a.m. No fire spread past the wall located at column 94-106 is evident despite the fact that fire was present at window 94-106 by 9:21 a.m. There are also two relatively small fires visible on the 93rd floor.

Figure 8-52. This enhanced and cropped photograph shows the north face of WTC 1 at 9:37:58 a.m. Column and floor numbers have been added.

On the 93rd floor there are two isolated regions of flame visible. One of these is at window 93-139 and the second is at windows 93-151 and 93-152. Many of the windows on this floor are open. The only fire evident on the 94th floor is a small spot fire in the cavity created by the aircraft. The fire on the northeast corner, which developed rapidly around 9:25 a.m. (see Figure 8-36) and filled windows 94-155 to 94-158 with flames, has already died down to a level where it not visible from this vantage point. The image provides sufficient detail to determine that the glass for windows 94-153 and 94-155 is still in place. This is an example where the apparent flame movement does not align with the wall placement indicated by the floor plan layout. The layout in Figure B-3 indicates that the wall for the room in this corner terminated at column 94-154. It is surprising that window 94-154 is not broken. No flames are visible on the 95th to 97th floors.

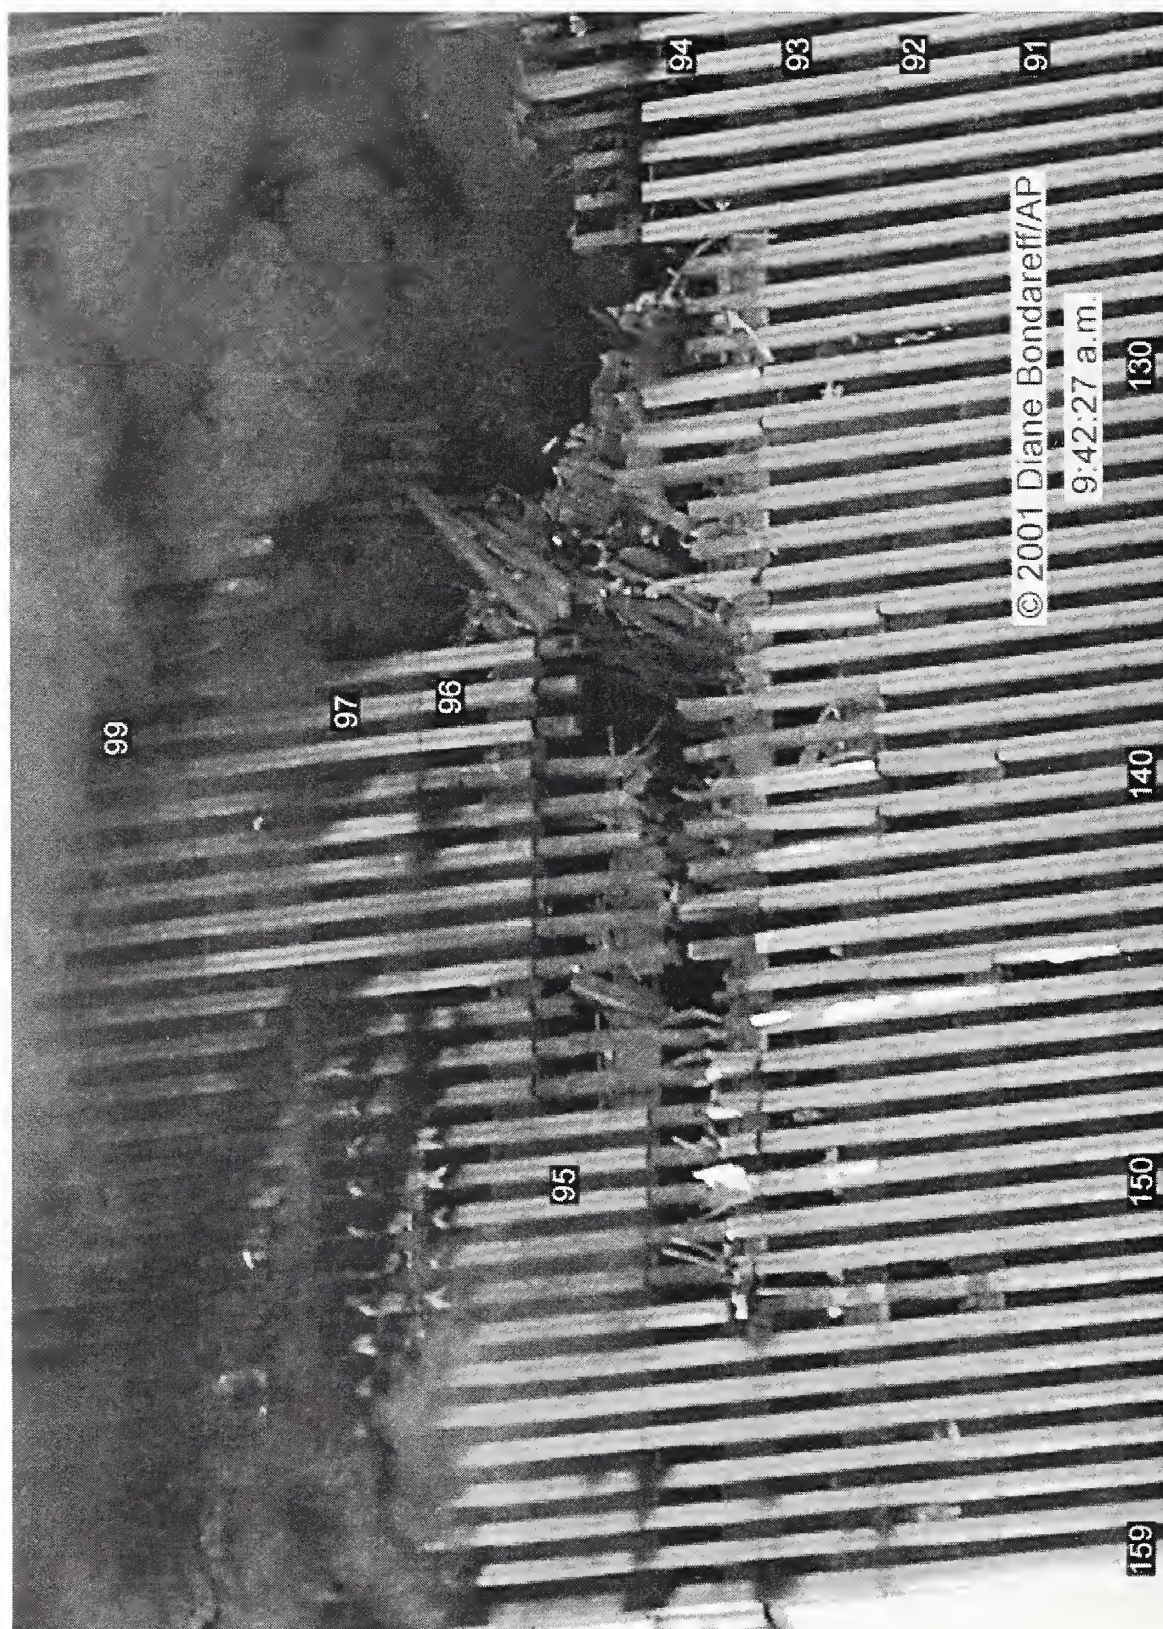
Figure 8-53 provides a clear view of the fires on the 98th floor, which extend from beyond the center of the floor on the west side to at least window 98-154 on the east. Even though the flames appear to be continuous, close inspection shows that in many windows there is simply an orange glow, suggesting that the fires are burning away from the windows at interior locations. The number of windows where flames are directly visible is limited. The only areas where flames appear to fill the windows are near the center of the face and around window 98-153.

Figure 8-53. This sharp photograph shows the eastern portion of the north face of WTC 1 at 9:42:27 a.m. The original version has been cropped and enhanced. Column and floor numbers have been added.

The fires on the north side of the 98th floor do not appear to be as intense as those observed at many other locations on the tower faces. Even so, they were large enough to break out the glass in multiple windows. Windows that were closed prior to the fire are now open. A review of the streamer observations summarized in Appendix L shows that numerous streamers were observed on the north face coming from the 98th floor during the early part of this time period when the fires were growing. Their source locations were spread out across the floor. This provides additional evidence that the streamers formed in regions where fires were breaking window glass.

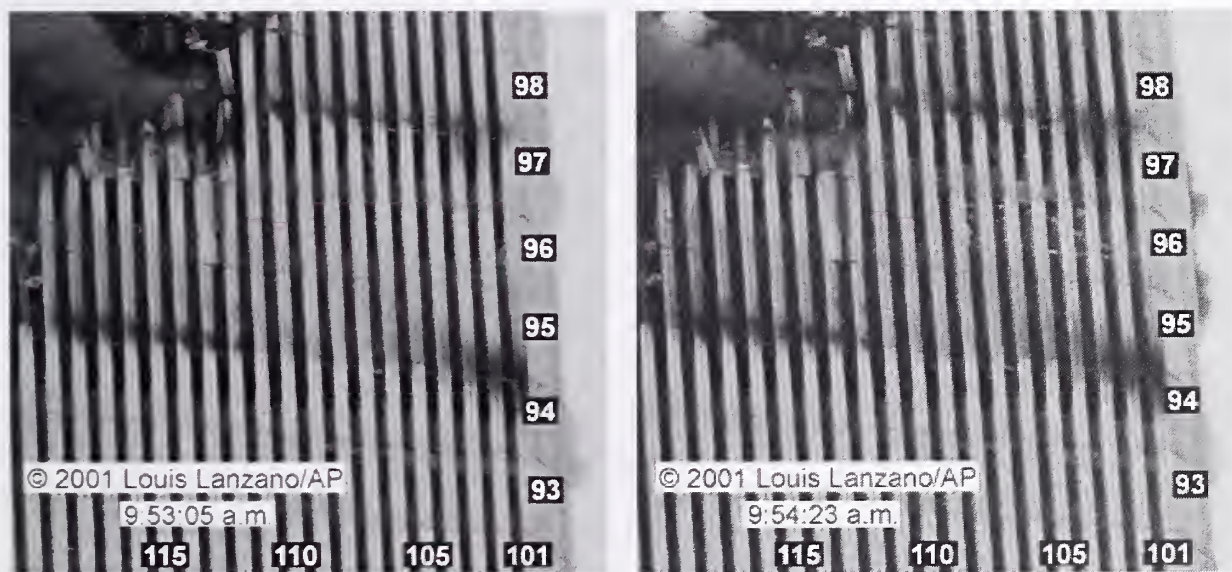
Figure 8-54 includes a photograph of this area taken at 9:53:05 a.m. Windows 94-101 to 94-105 are clearly open. The fires in the corner room have already died down to the point where they are no longer visible from this vantage point. All of the windows on the 94th floor within the view of the image are missing. At the same time, windows on the 92nd, 93rd and 95th floors and windows 98-101 to 98-108 on the 98th floor still have glass panes in place.

Figure 8-54. Two photographs of the west side of the north face of WTC1 taken at 9:53:05 a.m. and 9:54:23 a.m. are compared. The original photographs were cropped and enhanced. Column and floor numbers have been added.

In the photograph taken at 9:53:05 a.m., a small fire can be seen at the western edge of the 96th floor in window 96-101, while the glass for windows 96-102 to 96-110 is still in place. Videos show that there was a flash of light at window 96-101 at 9:53:00 a.m., which was likely associated with this window opening. At 9:53:20 a.m. the fire in window 96-101 grew visibly larger. During the following 13 s, fire appeared, moving from west to east over windows 96-102 to 96-107. This fire is evident in the second photograph included in Figure 8-54, which was taken at 9:54:23 a.m. The adjacent window, 96-108, was still in place at this time. According to the floor plan layout shown in Figure B-5, one of the walls for the room at this corner was located at column 96-108.

Even though the glass panes for windows 96-108 to 96-111 are still in place, a fire is visible growing rapidly further to the west in windows 96-112 to 96-115. The fire seen in window 96-113 is one of the few examples where flames are observed through a closed window. As discussed below, a significant fire was observed on the west face near the northwest corner prior to the rapid fire growth in the northwest corner room. This suggests that the fire broke into this corner room through the south wall located at column 96-456 (see Figure B-5). Note that there were two adjacent rooms attached to the south side of this wall. Fire movement from the south is also the likely source for the fire seen in windows 96-112 to 96-115.

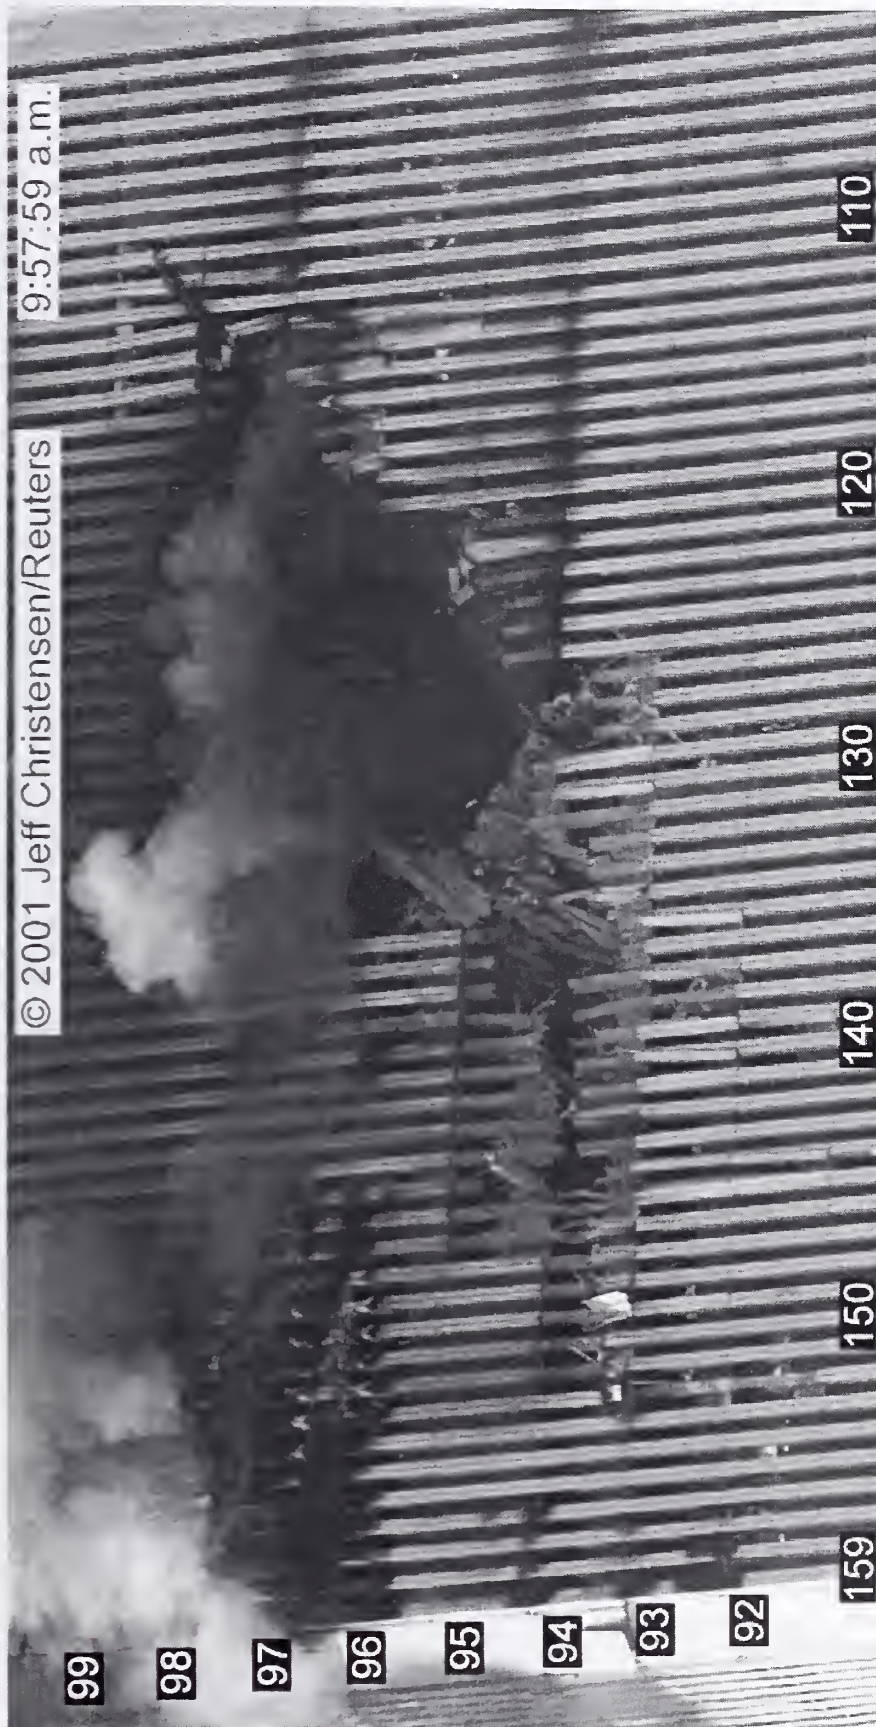
A photograph of the north face of WTC 1 taken at 9:57:59 a.m., i.e., one minute prior to the collapse of WTC 2, is shown in Figure 8-55. Several changes have taken place since the photographs in Figure 8-53 and Figure 8-54 were taken. The fires on the 98th floor have died down considerably, with fire primarily evident on the east side of the north face. The fires on the 92nd and 96th floors have also spread a little further. On the 96th floor, windows 96-108 to 96-111 are now open, and flames are visible in these windows. On the 92nd floor, the panes for windows 92-153 and 92-154 are missing, and flames are visible through these windows, as well as windows 92-151 and 92-152. Recall that walls for rooms in this area were located at columns 92-152 and 92-155 (see Figure B-1). This photograph has sufficient resolution to identify details inside the windows. It appears as if both of these walls are still present.

Figure 8-55. This image shows the north face of WTC 1 at 9:57:59 a.m. The original has been rotated, cropped, and enhanced. Column and floor numbers have been added.

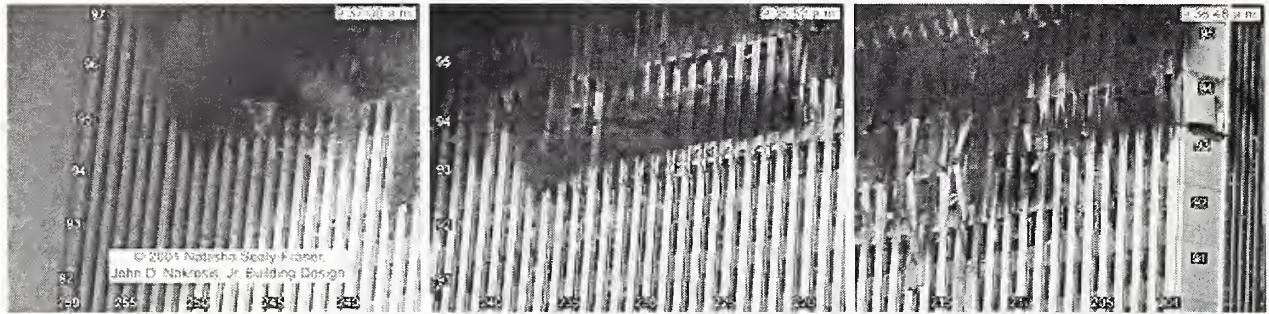
A number of close-up photographs and videos that provide views of the east face are available during the current time period. Figure 8-56 shows a series of three photographs that were taken around 9:37 a.m. They show the lower floors where fires have been burning. Note that the fires that are present on the 96th and 97th floors are not visible. In the right-most photograph fire is visible near the northeast corner of the

Figure 8-56. This series of three photographs shows various locations along the east face of WTC 1 around 9:37 a.m. Column and floor numbers have been added.

92nd floor in windows 92-201 to 92-207. Flames first appeared in this area around 9:33 a.m., and at 9:34:20 a.m. flames were coming from these windows. These flames had already begun to die down two and a half minutes later. The smoke markings on the adjacent column covers are interesting. They are a combination of carets and horizontal bands. There is also a smoke band above these windows. These markings suggest that while flames did extend from the windows, they were not intense enough or sustained for a long enough time to create well-defined carets. Well-defined carets are present just above on the 94th floor, as well as on numerous column covers on the 96th floor.

The same photograph provides an indication of the degree to which the flames that were present earlier on the 94th and 96th floors have died down. Only a couple of isolated fires are observed on the 94th floor, and no flames are obvious in windows 96-201 to 96-220.

In the center photograph of Figure 8-56, the fires that were present earlier on the 93rd, 94th, and 95th floors near the center of the east face have also died down and are no longer evident. There is still considerable evidence of interior fires on the 92nd floor, but the flames still do not seem to have progressed beyond window 92-237. As discussed earlier, flames were observed at window 92-237 at 9:21:01 a.m. The fires on the 92nd floor have caused some interesting effects on the surrounding façade. The variations in the types of smoke marks on the column covers adjacent to the windows have already been mentioned. Inspection shows that in the area immediately above windows 92-223 to 92-228, the aluminum spandrel covers have partially disappeared. The shapes of the missing areas indicate that they mostly likely melted due to heating from the hot fire gases flowing from below. In fact, spots of what appear to be solidified drops of aluminum can be seen on windows below this floor. Based on the melting temperature of aluminum, the fire gases leaving these windows must have been well in excess of 600 °C. Even though these gases were quite hot, they have not broken out the glass in the windows immediately above on the 93rd floor, which are heavily coated with soot, but remain in place.

The left-most photograph in Figure 8-56 shows the southern part of the east face. A jet of fire is coming from the 94th floor at window 94-246, and flames are visible in nearby windows. The carets on many nearby column covers indicate that flames have extended from many of these windows. The heavy smoke coming from window 94-149 indicates the fire on this floor has moved slightly toward the west since 9:34:20 a.m. (see Figure 8-43).

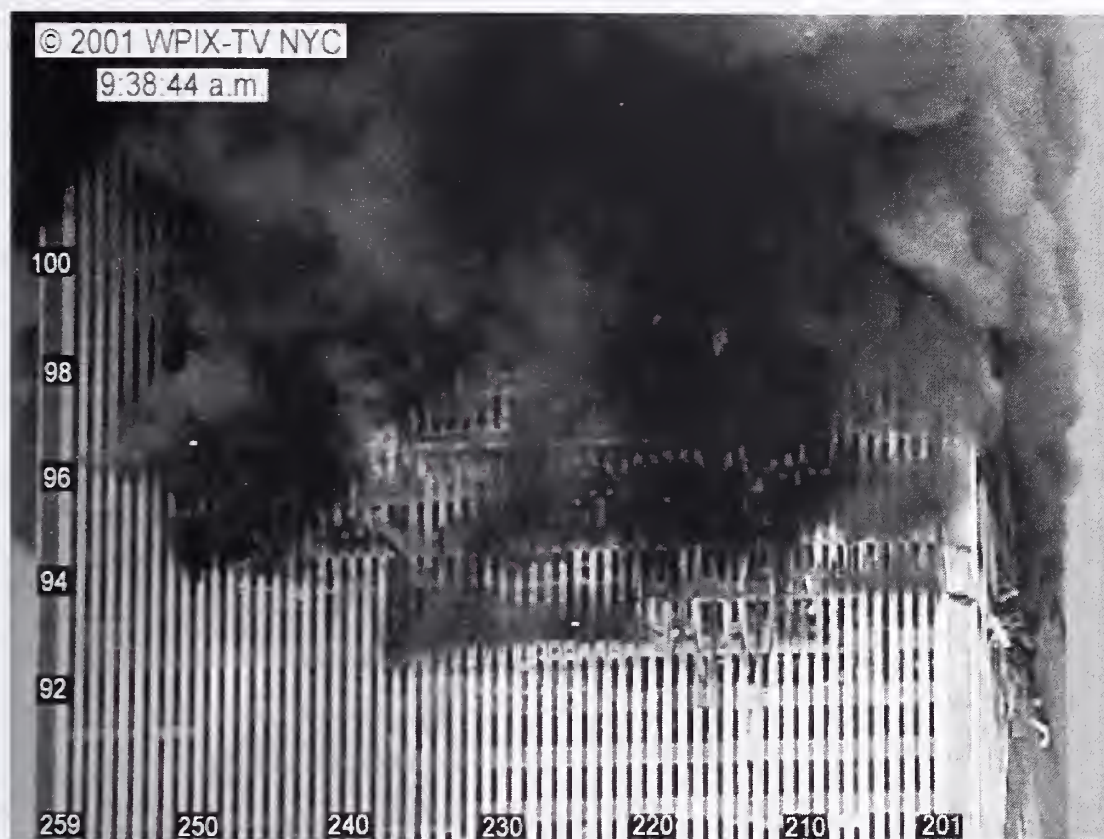
Figure 8-57 is a frame from a video of the east face taken at 9:38:44 a.m., which shows all of the floors with fires. This photograph was taken more directly from the east than Figure 8-56 and, therefore, provides a better indication of fire locations. Starting at the lower part of the figure, the fire on the

92nd floor is visible over a length from near window 92-223 to window 92-238. Despite the extent of the flames, visible smoke is only coming from near window 92-237. On the 93rd floor, flames are evident at the northeast corner and also in a region running from approximately window 93-213 to window 93-221. Flames are coming from the several windows on the 94th floor, centered near window 94-248, and flames extend over at least seven windows. A short flaming region is present on the 95th floor, centered near window 95-239.

Figure 8-57. This image of the east face of WTC 1 was captured from a video recorded at 9:38:44 a.m. It has been enhanced by adjusting the intensity levels. Column and floor numbers have been added.

There is an intense flaming region on the 96th floor, with flames extending a large distance from windows 96-237 and 96-238. Videos of this face around this time show that this intense flaming lasted several minutes. The intense region of burning has only moved a few windows to the south since 9:25:27 a.m. (see Figure 8-42). In contrast, very little flame is visible on the 97th floor, directly above, even though fires have burned to roughly the same location as on the 96th floor. Videos recorded at around the same time also indicate there was very little fire on this floor.

On the 98th floor, there is a localized jet of flame coming from window 98-215. A review of photographs and videos recorded around this time reveals that this flame was not apparent in close-up shots taken around 9:37 a.m. and that it is seen for the first time in more distant videos around 9:37:57 a.m. Recall that by this time a wide-spread fire had been observed on the north face of this floor for around 10 minutes. Unlike the fire that has just appeared on the east face, the flames did not extend from the north face and appeared to be of relatively low intensity. It is interesting that the first appearance of

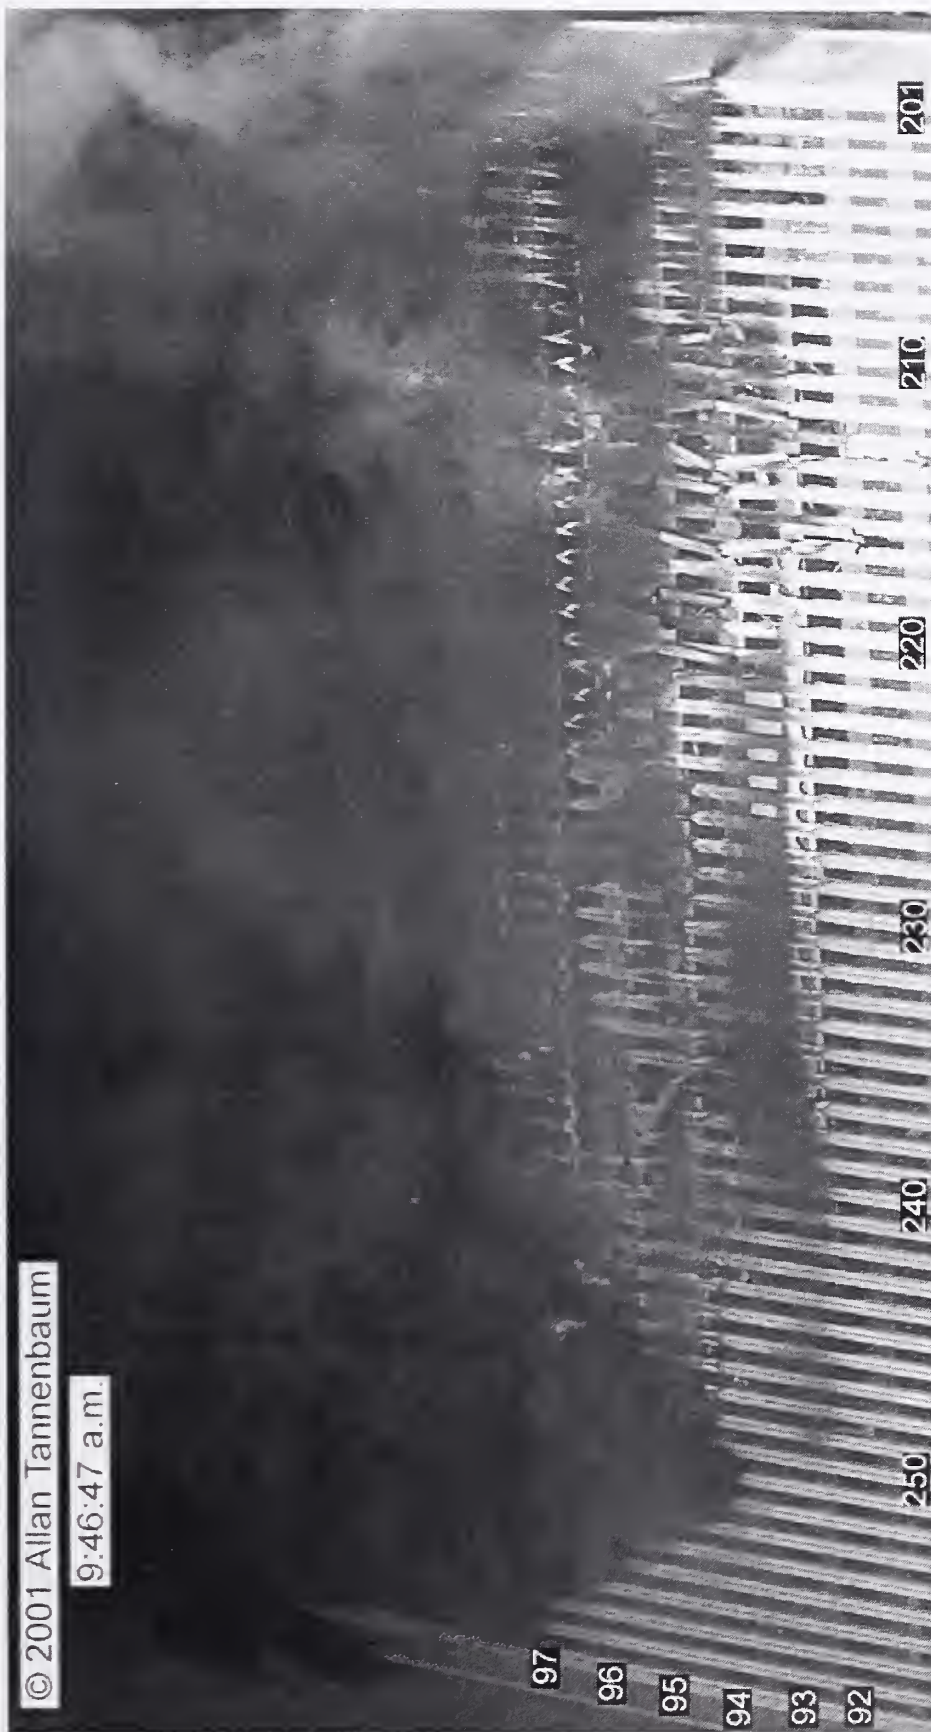
A close-up photograph of the east face, taken just over eight minutes later (at 9:46:47 a.m.) than Figure 8-57, is shown in Figure 8-58. There have been several changes in the fire distribution on the face during this time. The most dramatic change is on the 98th floor. Fire is now visible from window 98-208 to window 98-217. There is extensive external flaming from a large number of these open windows. The windows to the north of column 98-208 appear to have intact glass. The floor plan layout shown in Figure B-7 indicates that a wall for a room in the northeast corner terminated at this column.

On the 92nd floor, the fire, which had paused at window 92-237 for nearly 20 min, now has flames coming from window 92-248. At 9:39:28 a.m. there was a burst of flame from window 92-239. A photograph taken at 9:38:28 a.m. did not show any indication of fire having moved from its original location. In a photograph taken at 9:42:27 a.m., fire was present in window 92-240, but the windows further to the south still had intact glass. In a more distant photograph taken at 9:44:24 a.m., smoke appeared to be coming from a few more windows towards the south. Videos of the area show flames suddenly burst from window 92-248 at 9:45:06 a.m. Windows to the south of 92-248 were still intact in Figure 8-58 at 9:46:47 a.m.

In Figure 8-58, only small isolated fires are visible on the 93rd floor. On the 94th floor, the fire has continued its slow progress toward the south end of the face. Flames are now visible coming from window 94-250. This window had been open since the aircraft struck just over an hour earlier. Flames are visible in about ten windows to the north of this location. On the 95th floor, a smaller area of flame is present in roughly the same windows as on the 94th floor.

In areas of the face below and to the north of the current active fire areas there is little visual evidence of smoke or flames in the open windows. This indicates that fires observed earlier at these locations have either gone out or are now burning at very low levels. Figure 8-58 provides a good view of the various markings on the face described earlier, including the smoke marks on the column covers and partially melted spandrel covers.

Figure 8-58. This image shows the east face of WTC 1 at 9:46:47 a.m. The original image has been cropped, rotated, and enhanced. Column and floor numbers have been added.
